# SprintScan SCSI Troubleshooting Guide

## Windows 95, 98 and Me

May 31, 2002, Rev. 2.

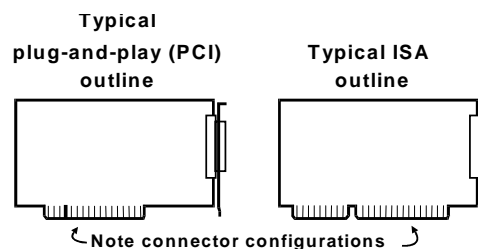
If you do not know your adapter model or if you have a brand or model not listed in the table above, you can usually identify the type by noting the outline of the adapter itself. The diagram below shows the differences between typical plug-and-play (PCI) adapters and ISA adapters.

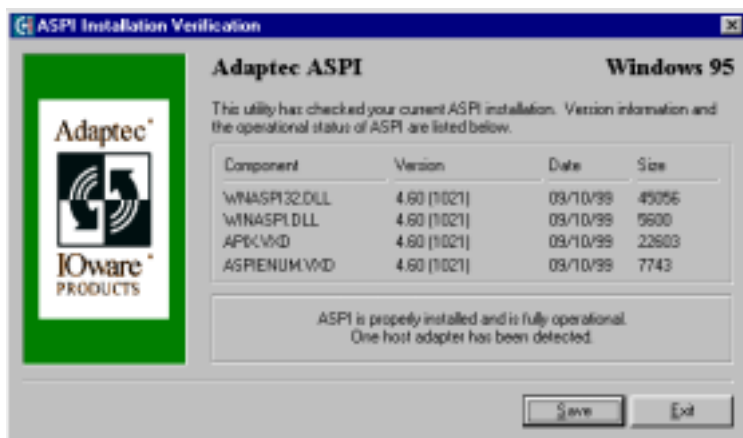
**Note:** You can check ASPI installation status by running ASPICLK.exe. The verification screen shown below will display a message confirming proper installation.
